Jubilee ROM Bin Safety Works

Crushing Plant

Jubilee Gold Plant

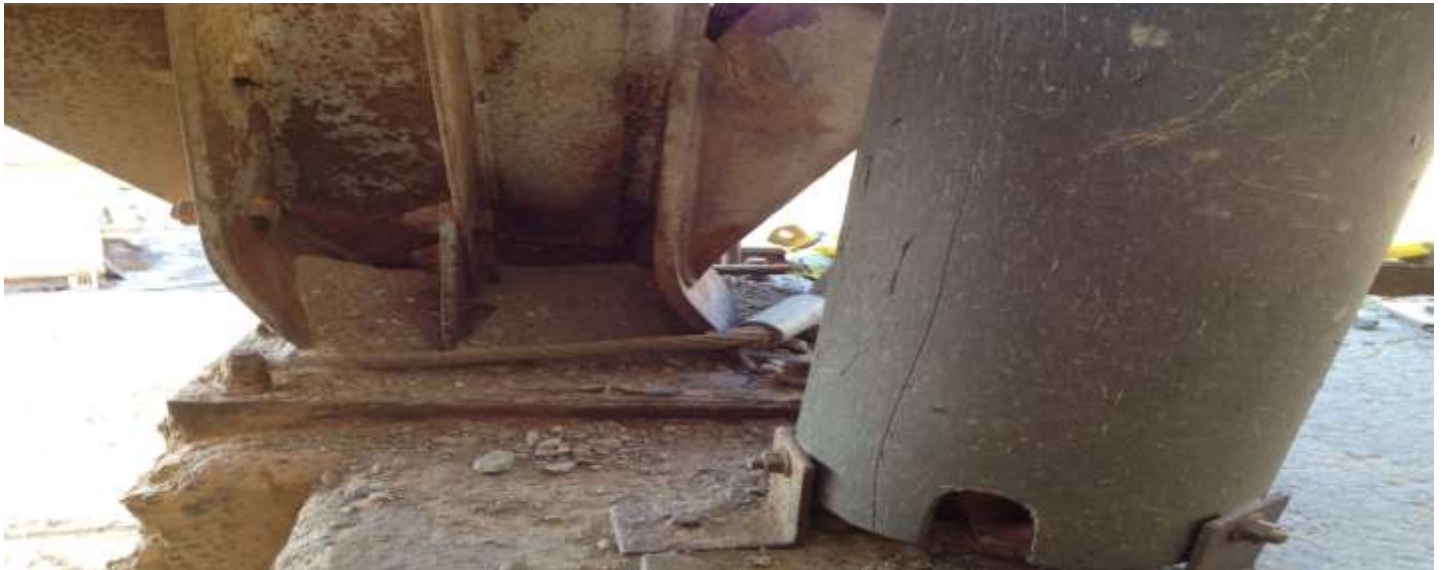
The ROM Bin had been damaged from a severe impact from a vehicle. Damage included buckling of the Bin Support Frame, as well as breakout of the anchor bolts. The problems were compounded by rust in the steelwork and very low strength concrete.

Como Engineers successfully completed the design of a supplementary structure to carry the Bin Loads down to new foundations on the ground and repair existing deteriorated concrete.

The design also included Como impact-absorption "fuse" technology to reduce the effects of a future similar impact to ensure the survival of the structure.
